NASA Contractor Report 178246

Test Results for Composite Specimens and Elements Containing Joints and Cutouts

P. T. Sumida, R. C. Madan, and A. V. Hawley

Douglas Aircraft Company
McDonnell Douglas Corporation
Long Beach, CA 90846

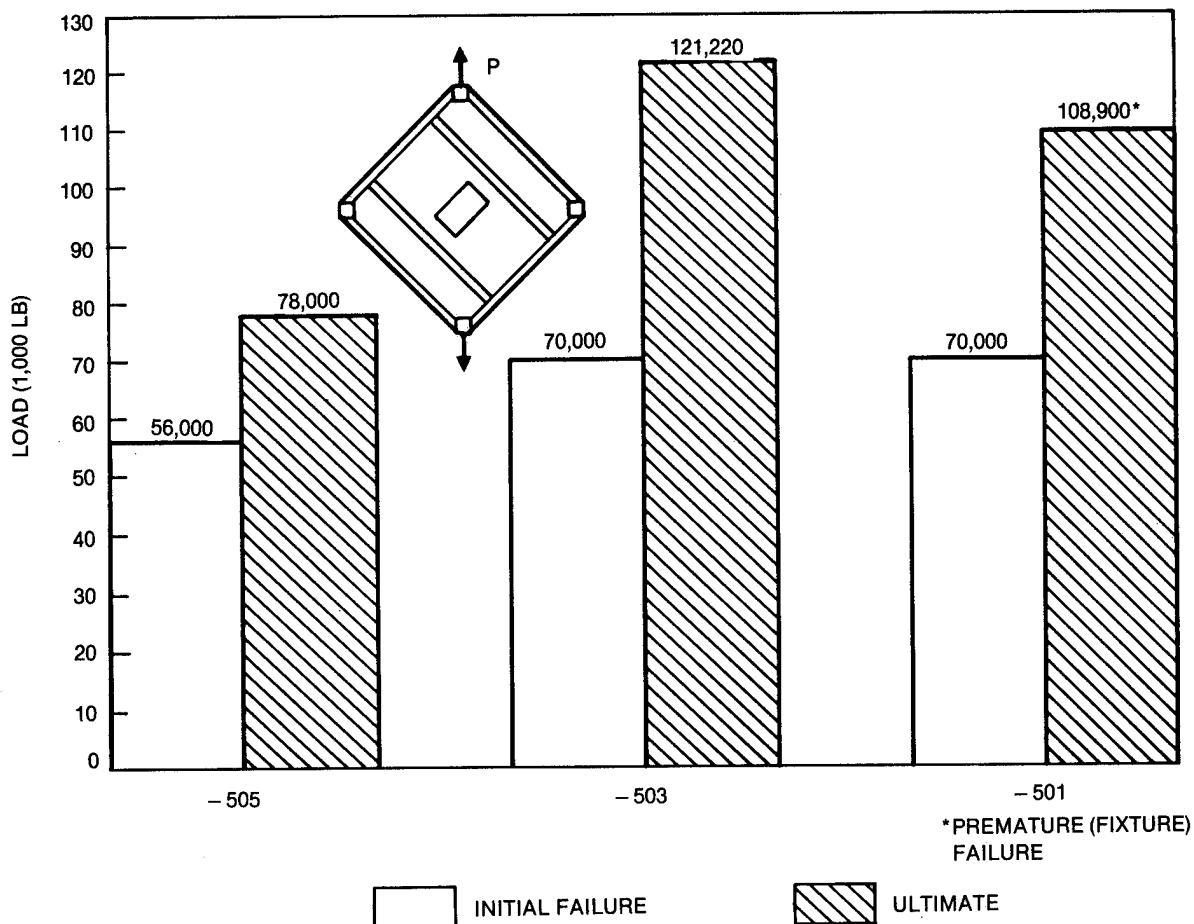
Figure 5-25. Failure Loads for Group B Shear Cutout Panels

A summary of the failure loads for the shear panel tests is given in Figure 5-25. All three panels failed initially at the top and bottom corners of the cutout. These localized failures did not result in the collapse of the panels, however. As indicated, the ultimate failure of the -505 panel was precipitated by a partial failure of the picture frame load introduction fixture. Strain gage data indicated that the panel was close to failure before this occurred.
